Smoke and Dye-Water Observation Summary

Western Run Pilot Project - Baltimore Maryland

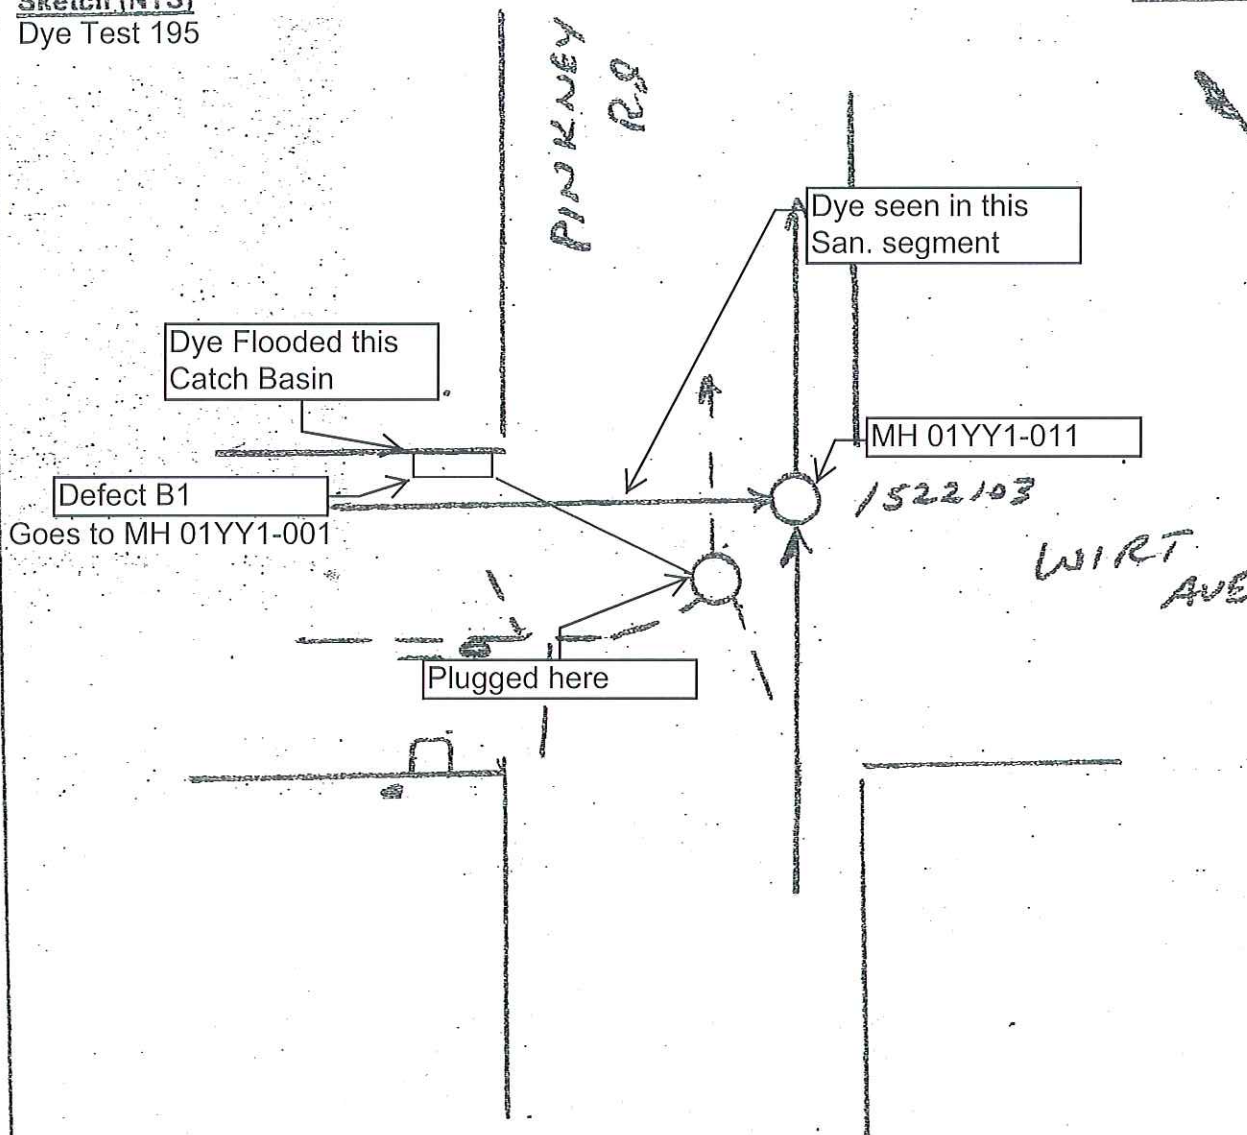
Sketch (NTS)
Dye Test 195

RECEIVING HOLES		SOURCE TYPE HOLES		
1. POSITIVE	1. MAIN SEWER	5. DOWN SPOUT	9. STAIRWELL DRAI	13. STORM DRAIN
2. NEGATIVE	2. SERVICE LINE	6. DWNSPT CONN.	10. FOUNDATION DRAIN	14. CATCH BASIN
3. CANNOT TEST	3. TRANSITION JOIN	7. AREA DRAIN	11. BUILDING INTERIOR	15. STORM MH
	4. CLEAN OUT	8. DRIVEWAY DRAIN	12. MH FRAME/SEAL	16. STORM DITCH
Additional Comments: Could not CCTV; No 6" set up. We lamped the line and saw the first 3 joints leaking then the line began to curve.
